Report No. CG-D-15-81

DRYDOCK EXTENSION

A 1980 Underwater Technology Survey for  
Extension of Time Between Drydockings

December 1980

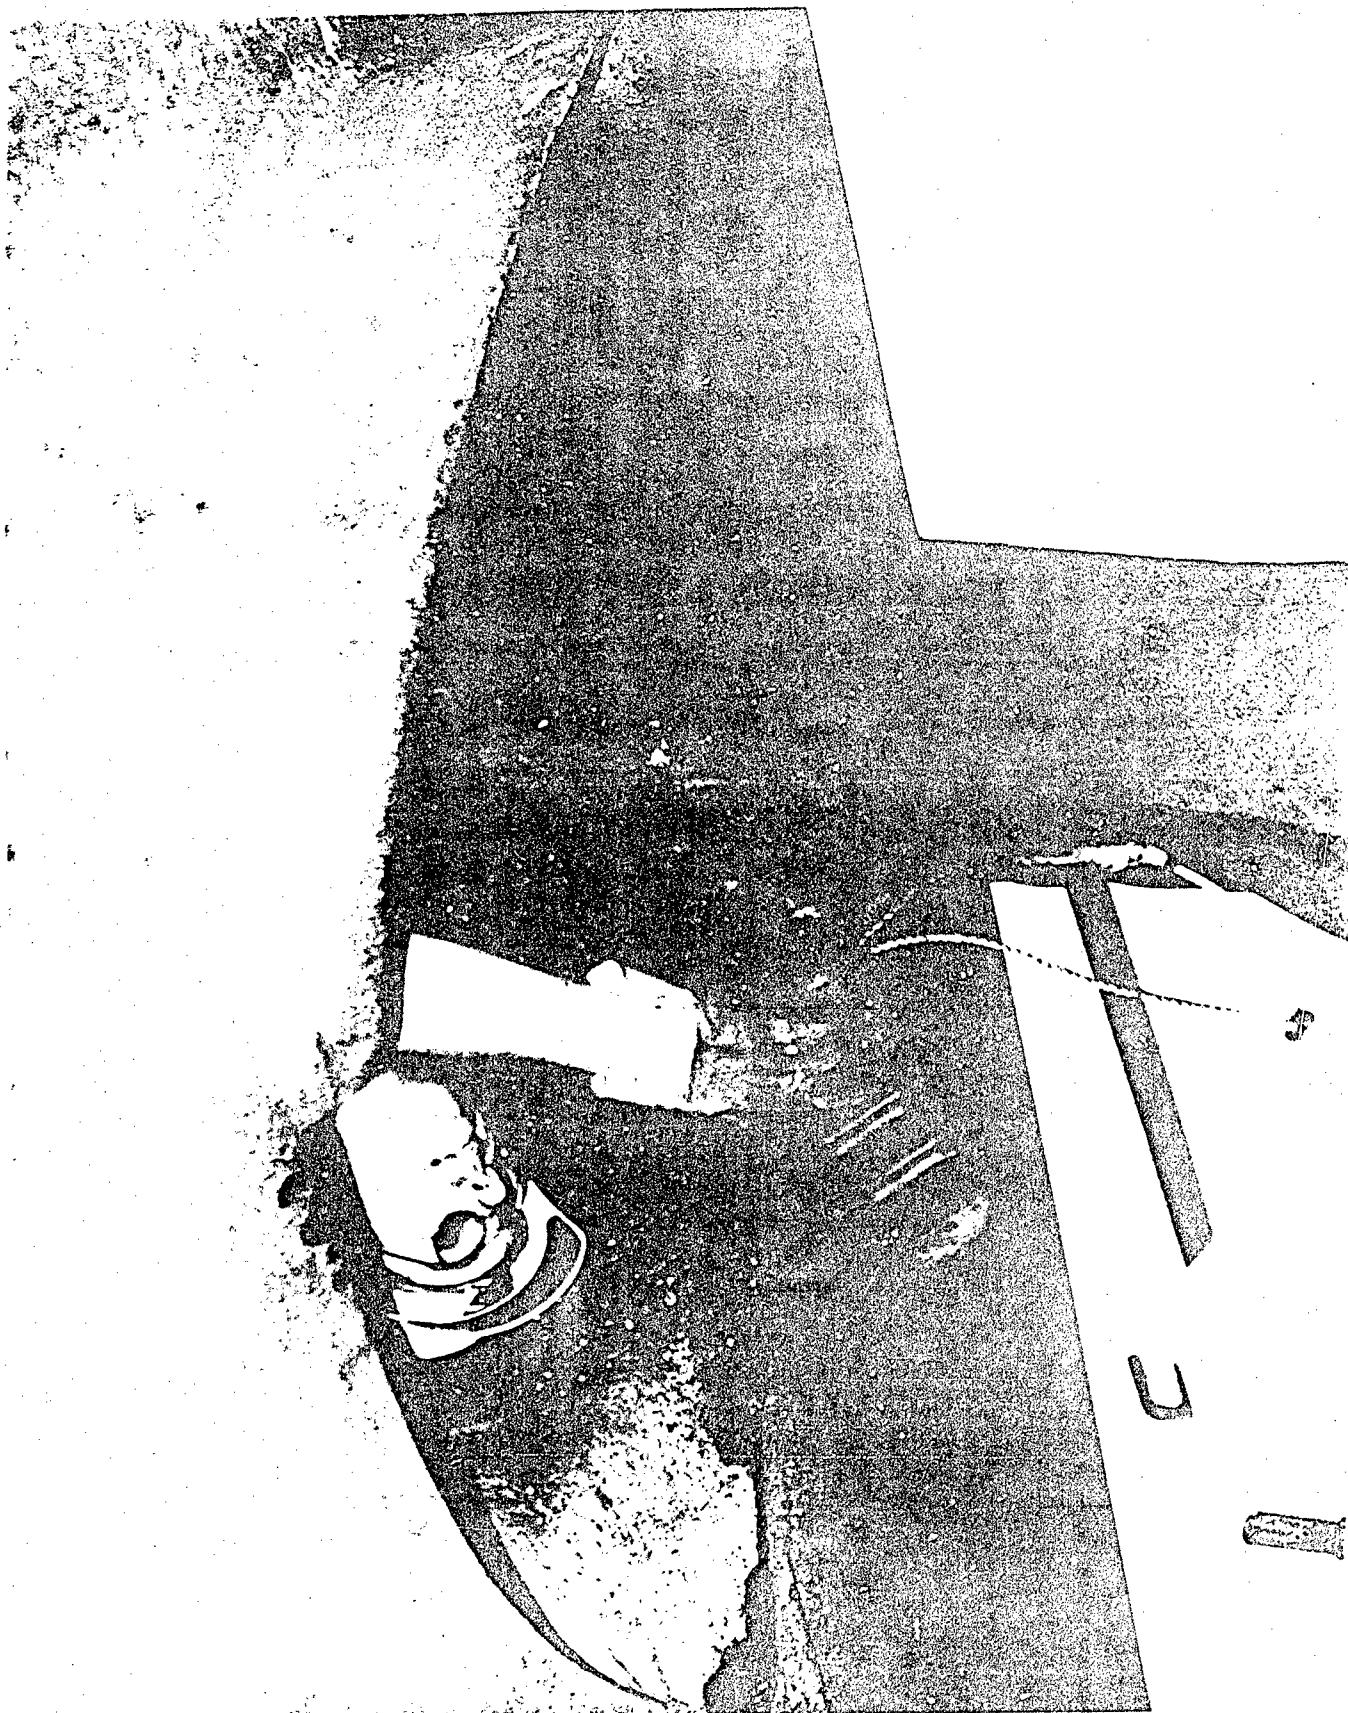
Figure 2-3 Inspection of main condenser scoop injection

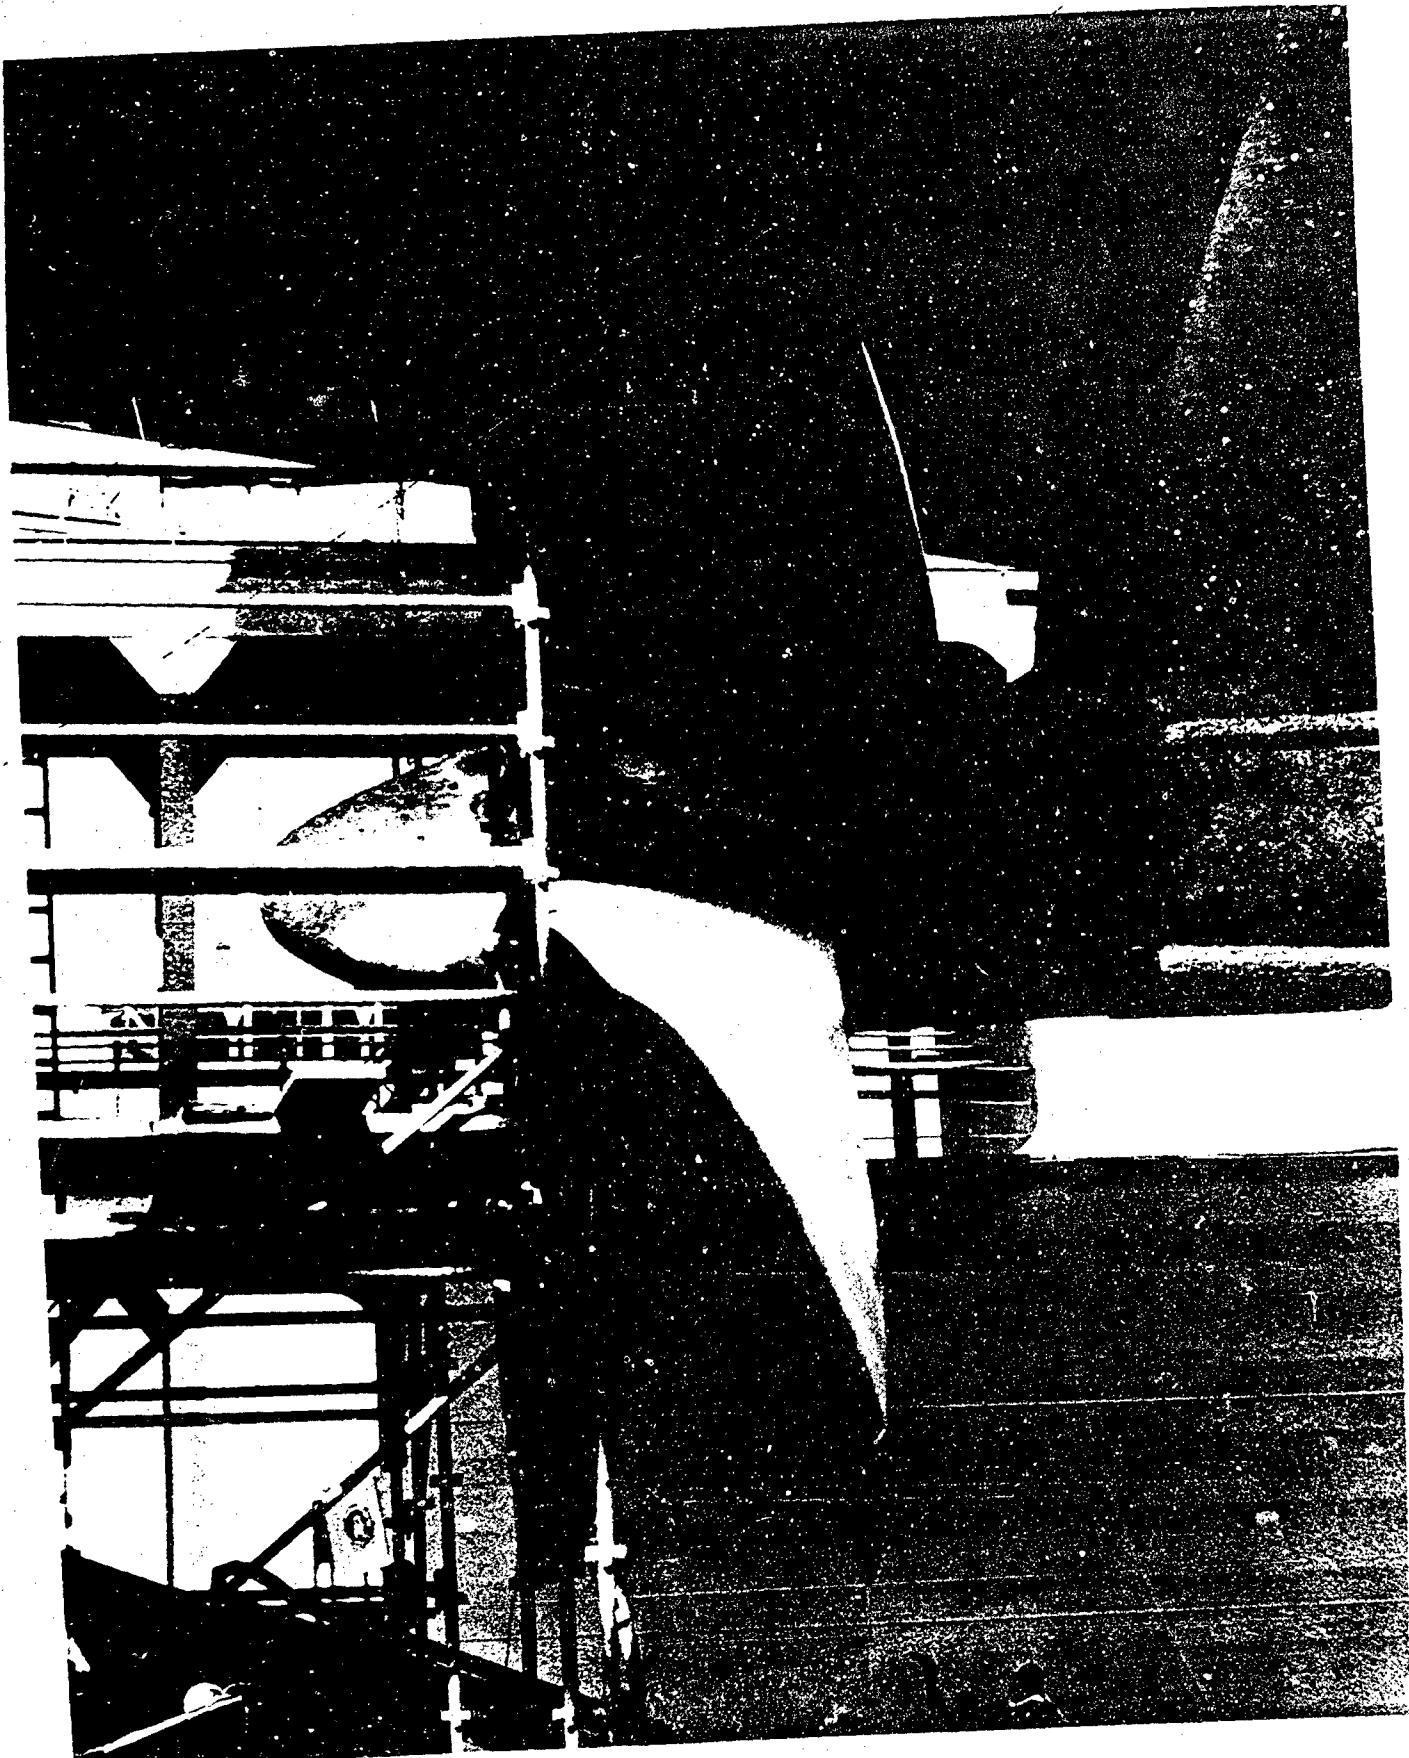
Figure 2-5 Propeller after cleaning. No repairs.
